SUBJECT: Site Assessment Report: General Die Casting Corp.
Detroit, Wayne County, Michigan
TDD # T059012014

**SITE ASSESSMENT REPORT
FOR
GENERAL DIE CASTING CORP.
DETROIT, WAYNE COUNTY, MICHIGAN**

JANUARY 1991

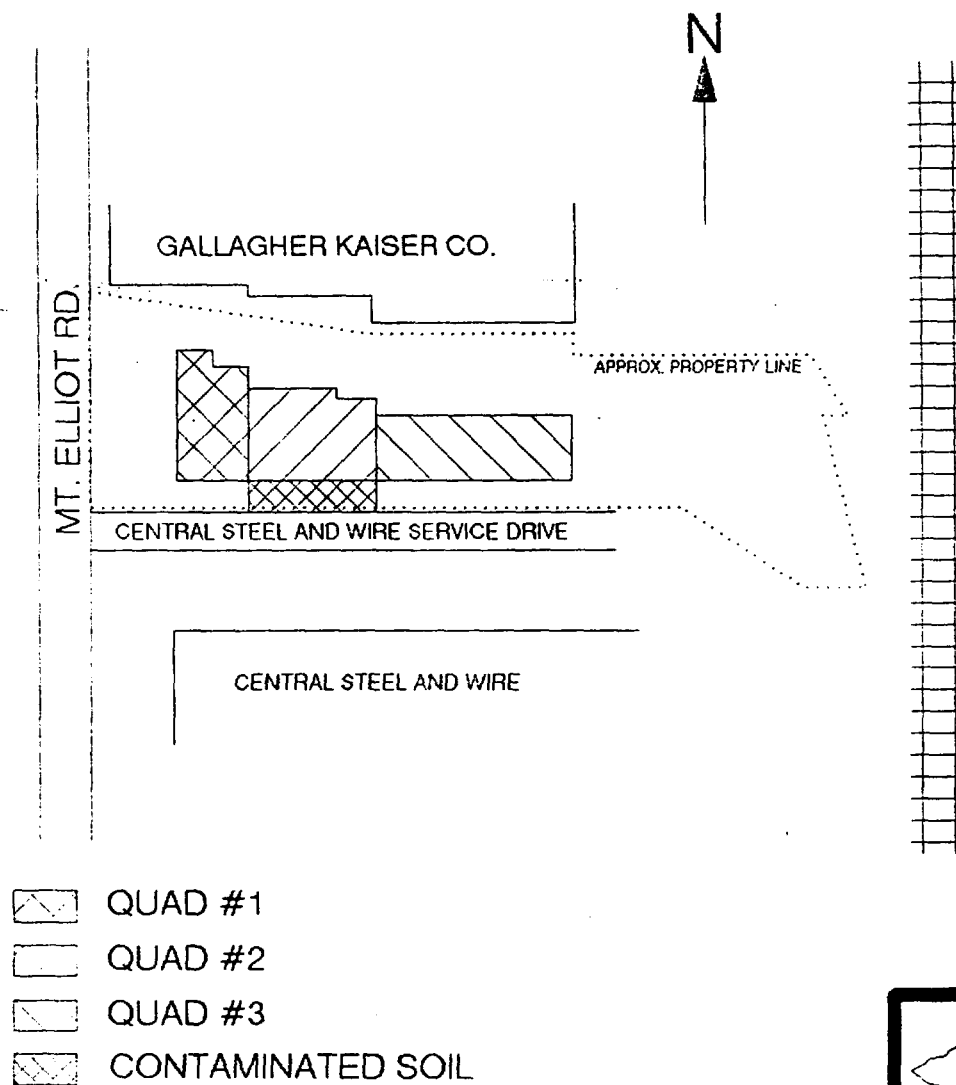
FIGURE 2
(NOT TO SCALE)

LOCATION OF HAZARDOUS SUBSTANCES (figure 2)

- o Quad #3; The waste treatment and storage area of plant contains several above ground storage tanks filled with solution. These tanks make up the electroplating waste treatment system. This waste treatment system is in good condition and probably has a significant value. There is a large amount of sediment in the containment area. The sediment is likely to contain heavy metal salts spilled from treatment. Many containers of used and unused materials are in this area including; 2-15 gallon sulfuric acid drums, 2-15 gallon Hydrochloric acid drums, 1 drum Semibright 430, 1 drum liquid nickel chloride, 3 drums ferric chloride, 1 drum liquid nickel sulfate, 4 drums Summysol 150, 4 drums swimming pool chlorinator, and 4 bags sodium carbonate. In general the containers seem in good condition. OVA readings in this area were less than or equal to that of the outside environment.
